JOHNS HOPKINS
UNIVERSITY

Applied Physics Laboratory

27 July 2000

Subject: Investigation into the Electrical Fire on the M/V Columbia on 6 June 2000

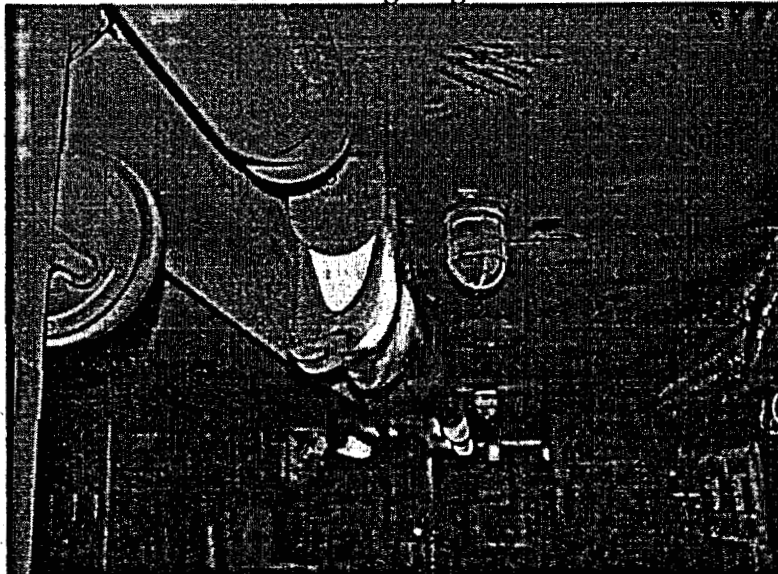
Attachment 5
Generator Breaker Contacts

The generators showed no external signs of damage. The number 1 & 2 generator breakers were disassembled and the contacts were examined. All of the contacts were in good shape with no evidence of abnormal operation, Attachment 5. The breaker arc arrester chutes were clean and showed no evidence of abnormal current flow entering or leaving the breaker.

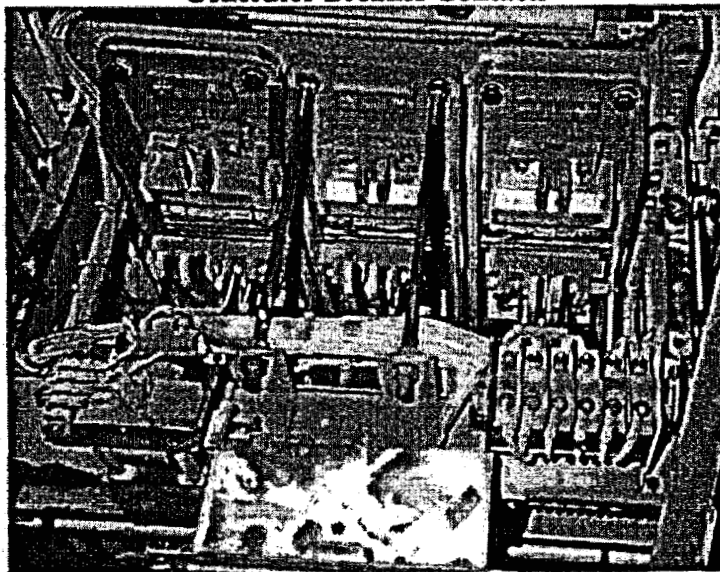
Attachment 6
Section 10 Overall Damage

In Section 10, vertical supply bus bars come up both sides of the switchboard. The resultant magnetic forces retard the travel of the arc on the finger bus. As the arc slows down, the heat becomes more localized and the damage rate goes up. The plasma enveloped the source finger bus of both rows of breakers at locations 9 and 10. When the plasma along the upper finger bus touched the top panel at location 11, the panel became an intermediate conductor for the electricity. A typical current path would be from phase A to the switchboard and back to phase B creating two arcs. Each of these arcs would continue to consume bus and switchboard frame, resulting in a large hole in the top panel. This has been confirmed in many

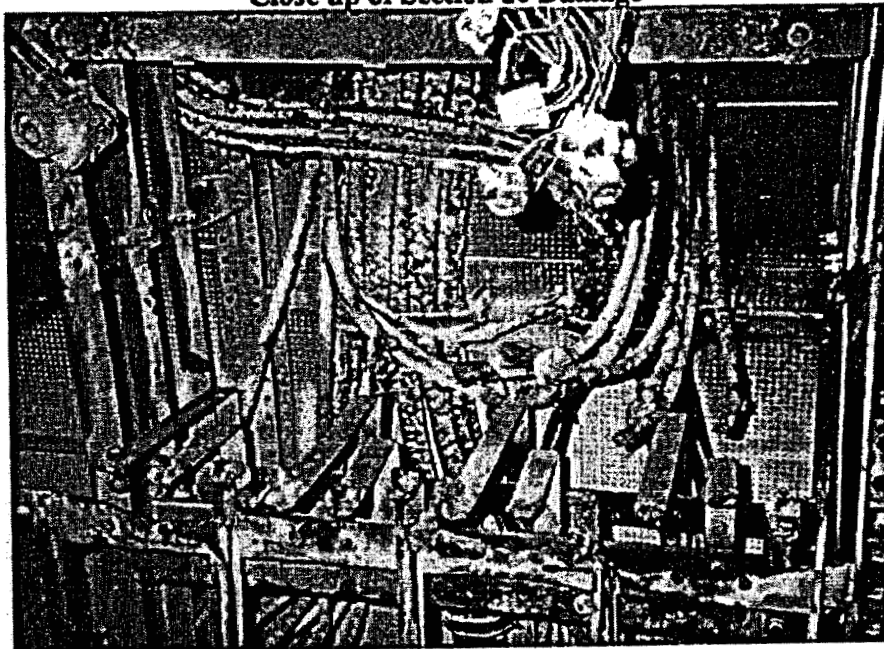
Attachment 9
Section 12 Damage

Attachment 9 shows that there was no damage to the finger bus on the top row of breakers in Section 12 or to the partition between the bus and the ventilation controls compartment in the top of Section 12. All of the supply finger bus supplying the middle row of breakers was heavily damaged, as can be seen in Attachment 10. The finger bus bars connecting to the second breaker from the left on the bottom row were severed behind the breaker, Attachment 11. Attachment 12 shows the vertical bus on the left side of Section 12. Splatter damage can be seen on the side facing into Section 12, but none was seen on the opposite side. Behind that is the vertical bus in Section 10 where both splatter and arc damage can be seen. Each of the load cables were inspected and showed external heat damage to their insulation; however, none of the cables showed discoloration to the copper strands. Pieces of nylon cable ties were reported by NTSB to have been found in the bottom of the switchboard.

Some of the molten metal from the arc is not vaporized, but just drops. Part of the molten metal from P456 dropped and created an arc on the source side of P442, location 4. While the bus behind P442 was damaged, the plasma cloud had not developed enough to bridge to any of the adjacent possible locations. Therefore, the arc at P442 happened late in the chain of events. See Attachments 9-11.

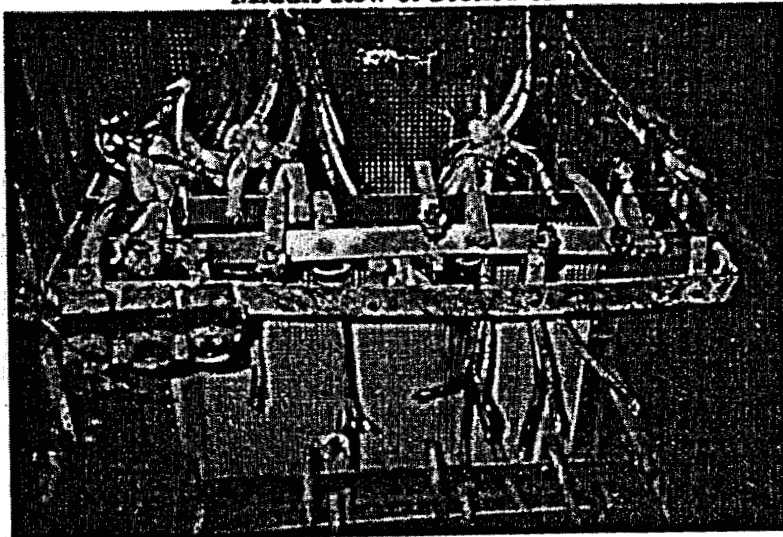
Attachment 11
Lower Row of Section 10 Showing P442 in Center

Attachment 15 is a photograph of a bolt found on the support angle just to the left of the second breaker from the left in the bottom row of Section 12, P442. The angle bracket can be seen in Attachment 11. The damage to this bolt is unusual in that the threads on the bottom side of the tip of the bolt are melted. The inside diameter of the two washers is melted (welded) to the bolt and there is melting damage to the bottom edge of the washer. The bolt contains a lock washer and a flat washer with an oversized outside diameter. This type of bolt and washer combination is used only within the switchboard to bolt the short piece of angled bus to the back of breaker and into the tulip clip.

A loose bolt, Attachment 15, was found on an angle brace just to the left of the top of breaker P442, Attachment 11. This was the only loose bolt found in one piece and it had unique arcing damage. All other bolts found with arcing damage were either in pieces or still installed in their original positions. Attachment 19 shows a scale drawing of the finger bus with the bolt and washers lying across the bus. Note that if the bolt were to lie on its side the washers would cock over at an angle as shown. As current flowed from one bus to the other through the bolt, it would leave arc damage at the points shown. When the washer is cocked on the bolt the current is forced to flow through the sharp corner of the washer inside diameter, ID. This concentration of current will produce localized overheating that welds the washer ID to the bolt. With the light weight of the bolt, the gas pressure from the arc generally kicks the bolt up and off of the bus. The bolt tends to rotate around its heaviest point, the head. Note that the observable damage to the bolt in Attachment 15 agrees with the postulations in Attachment 19. The most likely cause of the fault is that the bolt in question fell down across the finger bus behind P456 and initiated an arc. The bolt was tossed off of the bus and landed down on the angle iron where it was later found and the arc proceeded as explained under the arc origin section of this report. This scenario was duplicated in JHU/APL testing.

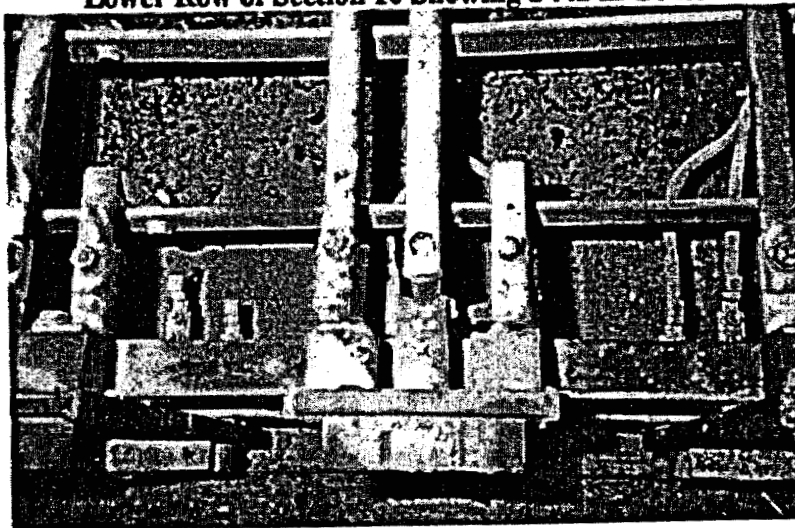
Attachment 12
Left Side of Section 12 Showing Vertical Bus

There were arc splatter marks on the right hand side of the vertical bus on the left side of Section 12, Attachment 12. These marks were in a line of sight of the arc on the back of P456. Additional splatter marks were found on the right hand side of the adjacent vertical bus in Section 10, location 8. Arc travel marks were found on the vertical bus in Section 10 showing that the arc moved up and out onto the finger bus. No arc travel marks were found on the vertical bus in Section 12. No arc splatter marks were found on the left-hand side of the vertical bus in Section 12 and the arc did not travel up the vertical bus in Section 12. Therefore, the arc could not have initiated in Section 10 and traveled to Section 12.

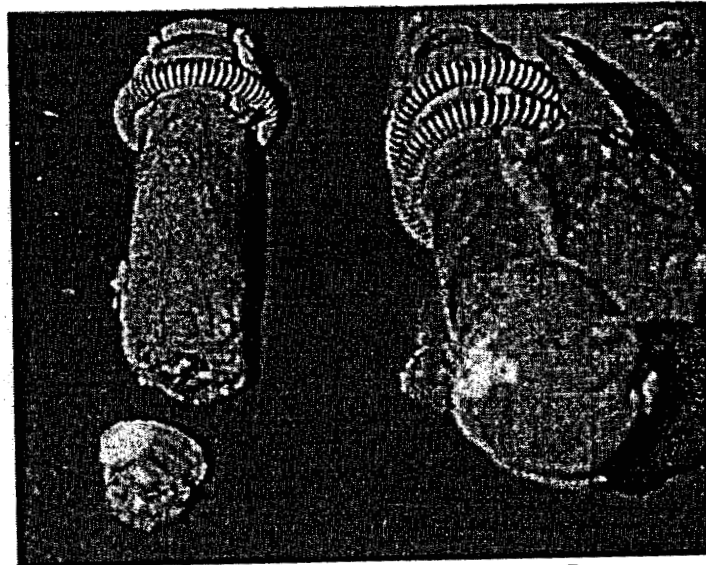
Attachment 15
Loose Tulip Clip Bolt

Even if the bolt's importance as the arc initiator is ignored; the origin of a loose bolt in a switchboard must be determined. This bolt and washer stackup is unique to the bolts used in the connections on the back of the breaker bases and could not have come from the switchboard frame. One could postulate that the bolt came loose from one of the breakers in the row above P456; however, all of those bolts were found in their proper positions. Another possibility is that the bolt came from the back of P456. Refer back to the array of tulip clips shown in Attachments 14. It is theoretically possible for the vibration of the ship to back the bolt out of the tulip clip. However, once the torque in the connection has been reduced to zero the connection will drastically overheat and fail. That type of failure should produce the type of damage shown in Clip 6. There would have been enough heat that the loose bolt could not fall out of the clip before a series arc in the connection melted the bolt and bus.

Generally when an arc is started by a loose connection the faulty connection is vaporized. Therefore, one concludes that a loose connection was at fault only after ruling out all other possible causes. Here we are sure that the arc damaged bolt caused a fault across two bus bars. It is highly unlikely that the bolt came from a functional position. It is most likely that it was a loose bolt. Therefore, it is most likely that the bolt was the primary cause of the fire.

The basic cause of the fault was the existence of a loose bolt. Once that shorted the bus the damage proceeded in a fashion predictable from numerous JHU/APL tests and previous Navy switchboard fires. A loose bolt should never have existed inside of the switchboard. This bolt should have been found during the close out inspection of the switchboard after the work was completed in April 2000. Safety awareness by the shipyard and the ship needs to be reinforced. They should always treat work in the switchboards carefully. Before the switchboards are closed all parts and tools should be accounted for. The Navy goes so far as to require that a second person perform a close out inspection after the inspection by the workers.
